# Advisory Mission on Infrastructure Resilience after Cyclone Ditwah

## FINAL REPORT

10-21 December 2025

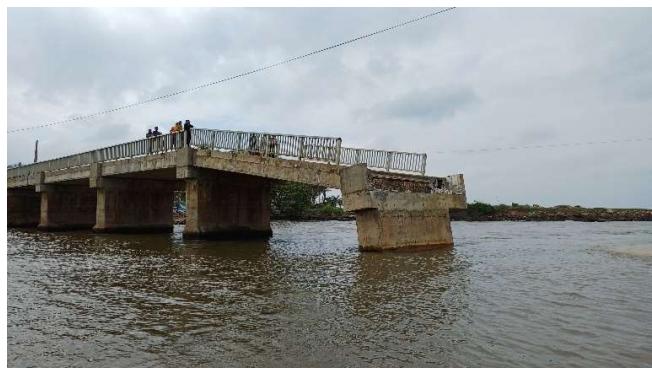
During the flood event, the bridge suffered severe structural damage with the collapse of the sixth and seventh spans. The failure was caused by the collapse of an intermediate pier, while the adjacent pier that remained in place shows residual rotation and settlement due to intense foundation scour. Based on the measurements carried out and presented, the local scour depth appears to exceed 7 m.

The main cause of the damage is attributable to foundations that are effectively shallow and founded on alluvial material, in contrast with the design documents that indicated foundations anchored into rock. The absence of scour protection measures facilitated the progressive erosion of the riverbed, leading to loss of support, pier rotation, and overall structural instability.

*Photo 2 – View of the bridge section affected by the collapse*

- Safe removal of the damaged part of the bridge and debris.
- A rapid assessment of the bearing capacity and scour stability of the existing foundations should be carried out, based on updated bathymetric data to evaluate the safe reuse of the remaining structure with a temporary solution for the collapsed section
- Install a temporary Bailey bridge at spans 6-7 of the bridge, considering the reuse of the existing undamaged spans, subject to a preliminary structural condition assessment.

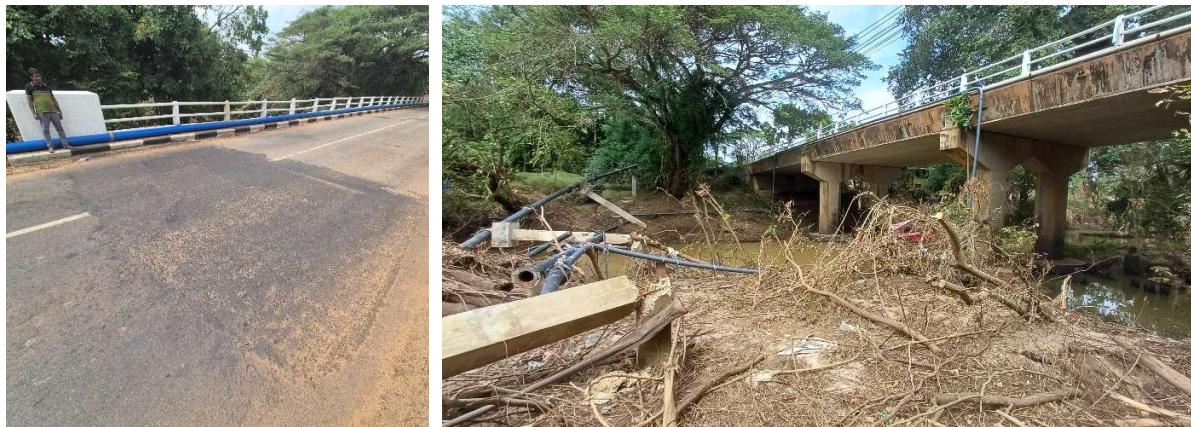
No damage to the main structural elements of the bridge was observed. However, the morphology of the river cross-section upstream and downstream has been altered. On the embankment approaching the left abutment of the bridge, a localized pavement collapse caused by washout of soil occurred; this had already been repaired (embankment refill) at the time of the site inspection. Some nearby structures (pipe crossings) have collapsed and partially obstruct the river section. The riverbed contains sediments, vegetation debris, and wooden remains.

Picture 2 - View of the bridge from the left abutment, showing the repaired sinkhole (left), and the general condition of the riverbed after the flood (right).

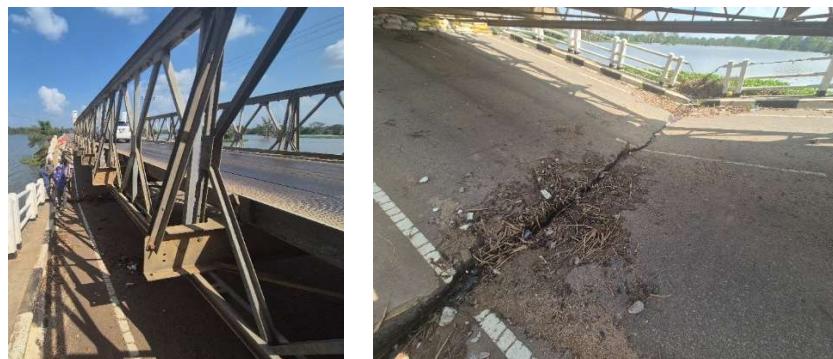
The causes of the bridge collapse can be attributed to the effect of scour at the central pier. The hydraulic cross-section of the bridge seems to not adequate for the for the discharge of the downstream dam on case of major floods. Additionally, the section is partially obstructed by a significant presence of aquatic vegetation upstream of the bridge, resulting in a reduction of the effective hydraulic section. This condition may have further contributed to a local increase in water velocity and hydrodynamic forces. During the flood event, overtopping of the deck is reported to have occurred.

Photo 2 – View of the Bailey bridge (left), view of the bridge collapsed at the central pier (right).

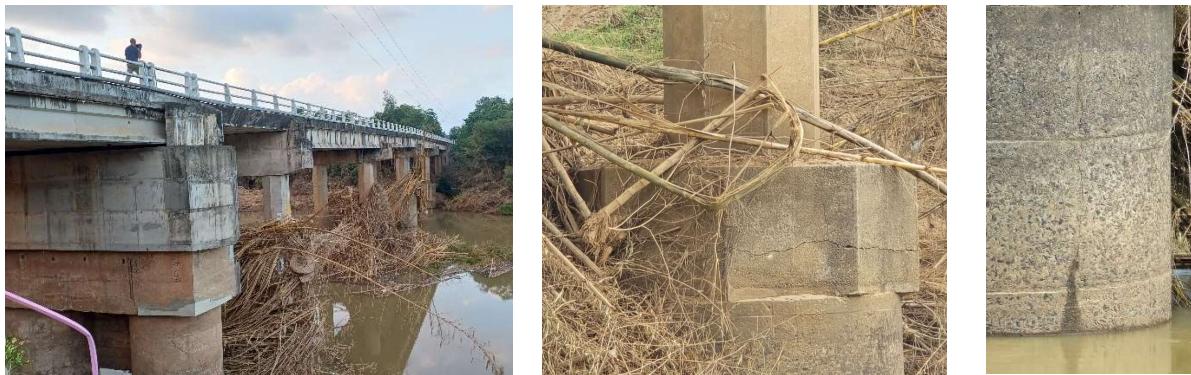
transported by the current. As evidenced by the exposure of the caisson foundations, the river morphology is altered due to erosion in the section close to the bridge.

Photo 2 – View of the vegetative debris (left), details of cracks on foundation elements (central, right).

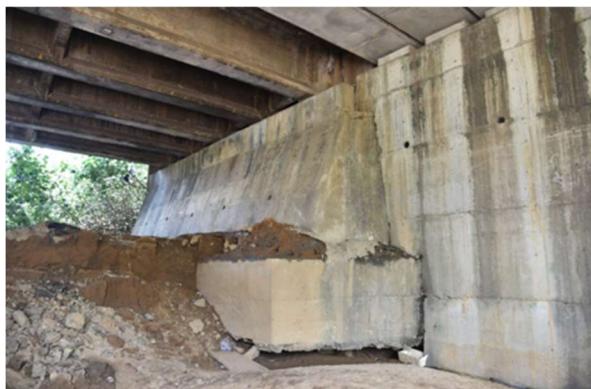
Following the flood, only a very slight rotation of the central pier of the old bridge is reported, likely due to a possible undermining of the foundation due to scour. The joints between adjacent spans are very small, and traces of moisture and efflorescence can be seen on the surfaces of the beams and the lowerside of the deckslab (specially the oldest one) and on the piers cap.

*Photo 2 – Detail of the two abutments.*

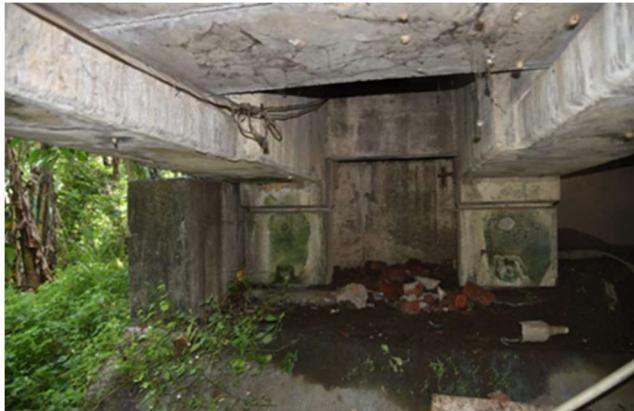
The joints between adjacent spans are very small, and traces of moisture and efflorescence can be seen on the surfaces of the beams and the lower side of the deck slab (specially the oldest one) and on the piers cap and in r.c. berings.

*Photo 2 – Detail of the bearings on the piers/abutments cap*

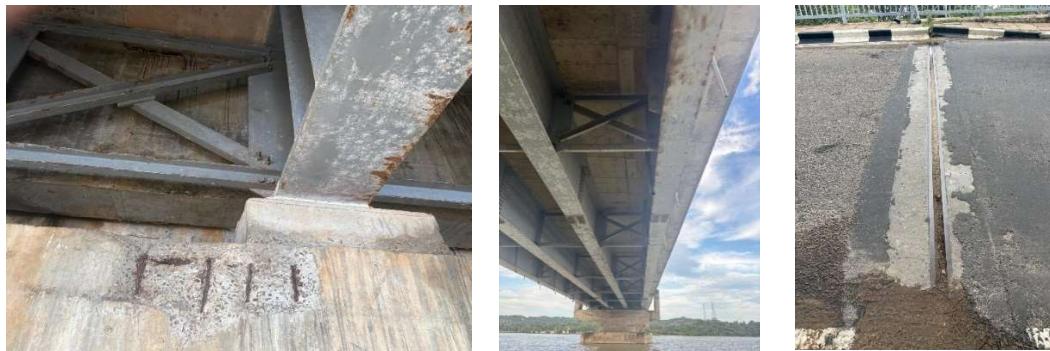
No global structural damage attributable to the flooding event was observed. The piers and the bridge deck do not show any visible signs of damage. However, degradation of structural materials was noted, particularly affecting the concrete and the embedded reinforcement bars, which are subject to corrosion. The steel bearings are not directly accessible for inspection however, signs of oxidation were observed on the protective casings. Water stagnation was identified at the abutment walls, in the proximity of the bridge supports. In addition, some drainage systems on the bridge deck were found to be partially non-functional.

*Photo 2 – Details of the corroded elements (left, central), detail of the joint (right).*

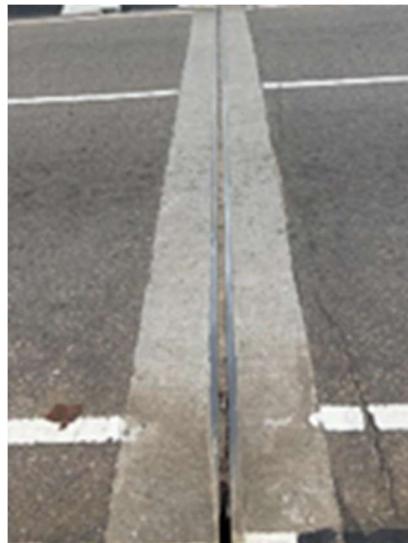
The visual inspection did not reveal any visible structural damage due to the recent flood event; however, the presence of debris obstructing the expansion joints was observed. There are only general considerations regarding bridge management.

*Photo 3 - Detail of the joint*

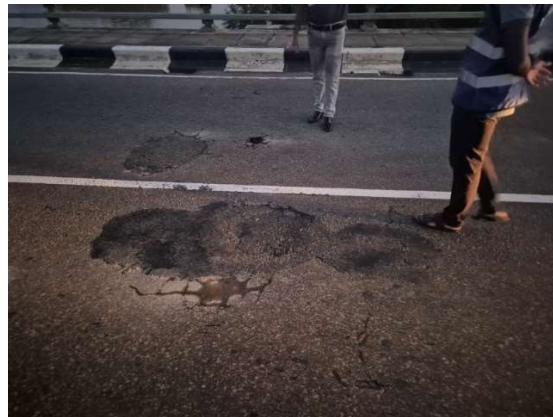
Visual inspection indicates visible localized non-structural damage on the deck carriage, due to settlement of the road pavement. A filling intervention with asphalt has already been carried out.

Photo n.2 – View of damage to the asphalt pavement.

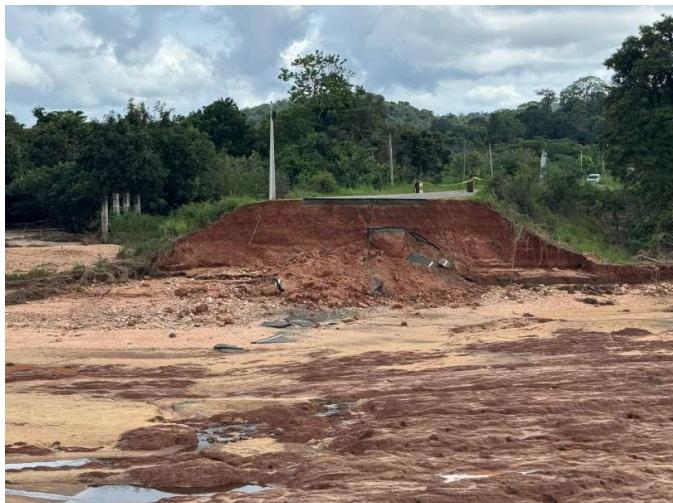
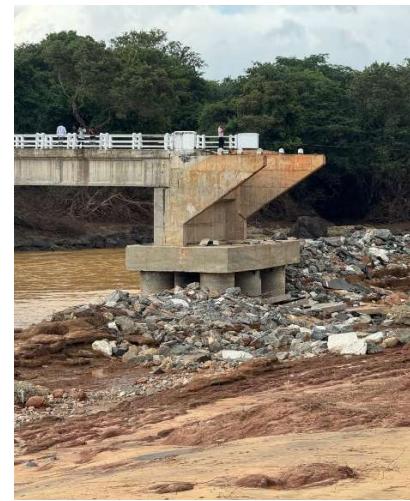
From structural point of view, the bridge is in good condition, but one of the abutments has its upper part of the foundation completely exposed due to the scour (at least for 2 meters). The flood arrived from the dam, has been concentrated on the body of the embankment behind the abutment, therefore the entire embankment was swept away by the current for several dozen meters, destroying the entire roadway above. The cause of this failure can be found both in the flow rate released by the dam during the event, and in the direction of the water flow released by the dam, which does not appear to be aligned with the bridge, unlike the original riverbed. Traces of moisture and efflorescence can be seen on the surfaces of the beams and the lowerside of the deckslab and on the piers cap.

*Photo 2 – Damage to embankment and right abutment completely exposed.*

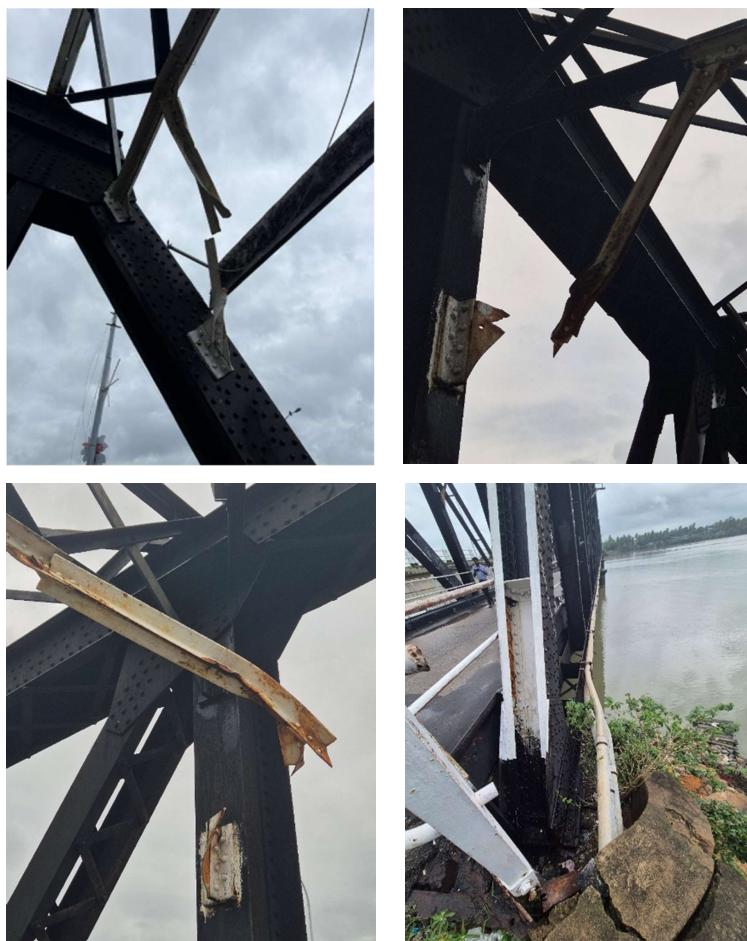
The buckling of the diagonal bracings is mainly attributed to the transit of heavy trucks carrying large containers in the past. The expansion joints are also damaged, primarily due to inadequate maintenance and prolonged exposure to heavy vehicular traffic.

*Photo 2 – View of damage to the diagonal bracing members and general conditions of the abutment*

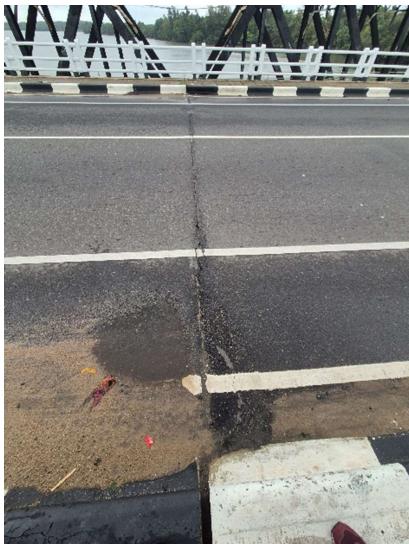
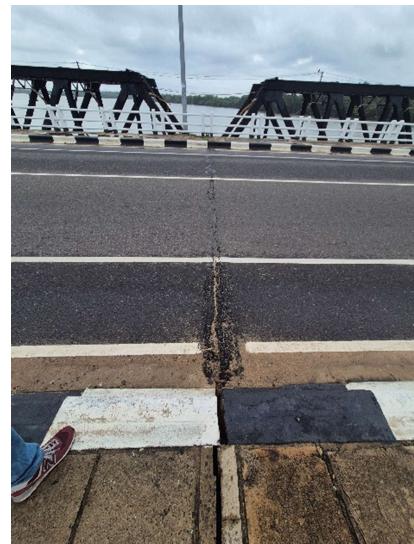
The visual inspection did not reveal any visible structural damage due to recent flood event; however, the presence of debris obstructing the expansion joints was observed. There are only general considerations regarding bridge management.

*Photo 2 – Detail of the joints*

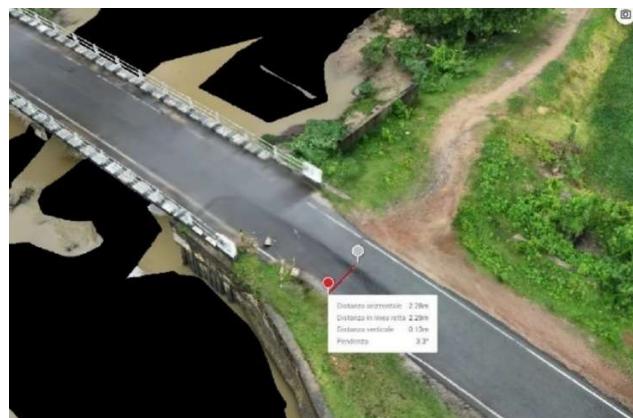
At the foundation level, concrete degradation and scouring were observed near the waterline, suggesting the presence of erosion. The intermediate pier seems tilted, likely associated with rigid ground movement and foundation instability. On the embankment approaching the left bank abutment of the bridge, a localized pavement settlement is caused by washout of soil occurred. A drone survey for 3D-modelling was carried out during the assessment.

Photo 3 - Damage in proximity of the abutment (left) - 3D-modelling through drone survey and assessment of the damaged area (right)

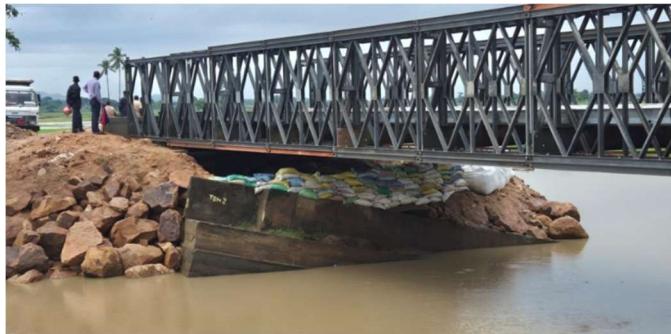
*Photo 2 -Damage to the abutments*

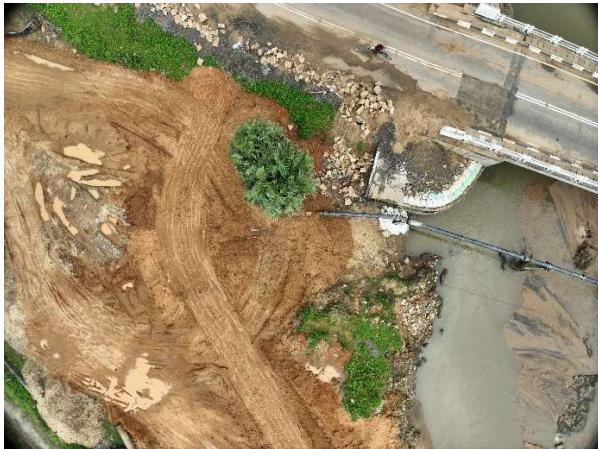
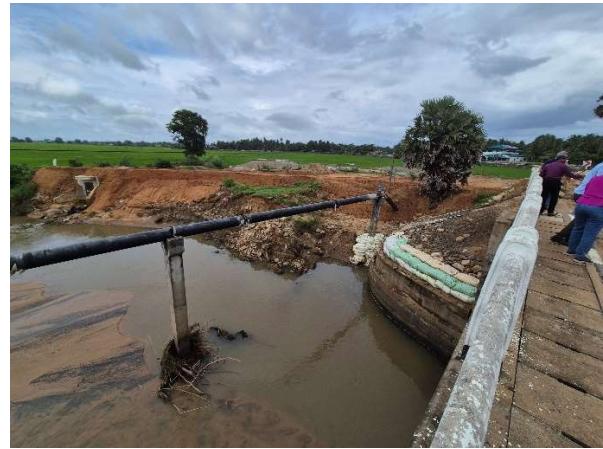
*Photo 2 -View of damaged abutment to wing wall*

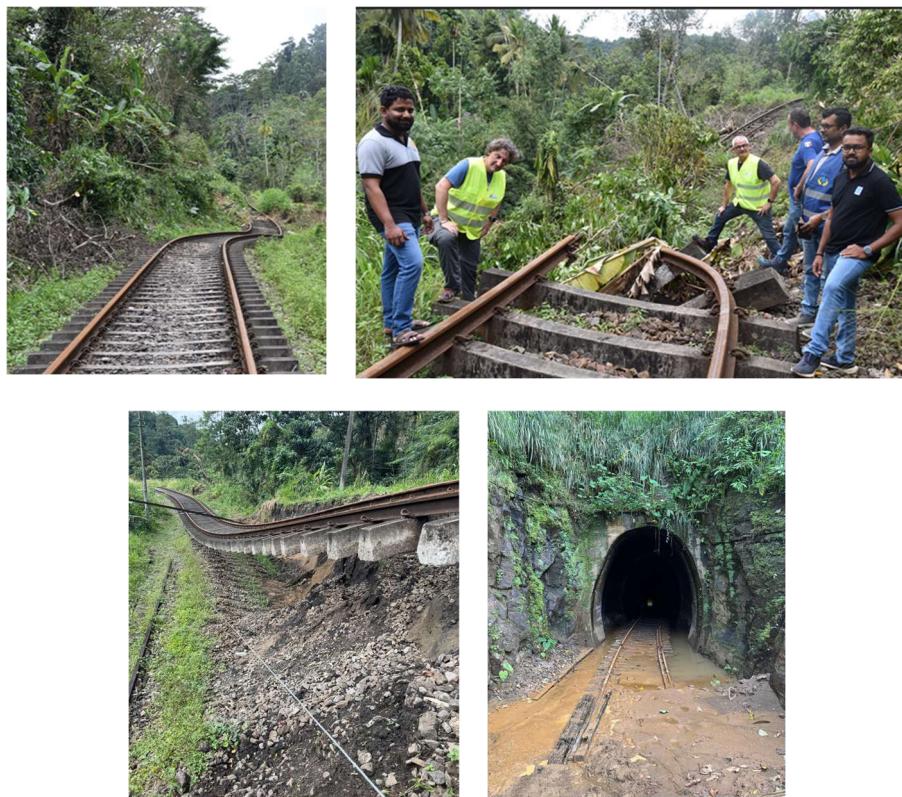
*Photo 2 – Detail of first (upper left), second (upper right), third (lower left) landslide and tunnel 09 impacted by debris (lower right).*

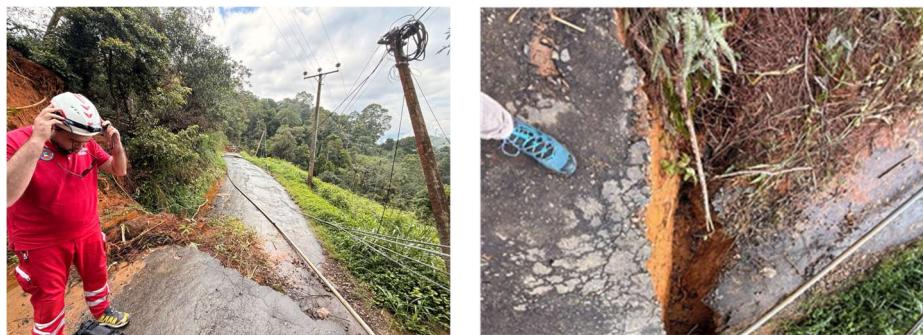
Photo 2 – Road damages.
