# Advisory Mission on Infrastructure Resilience after Cyclone Ditwah

## FINAL REPORT

10-21 December 2025

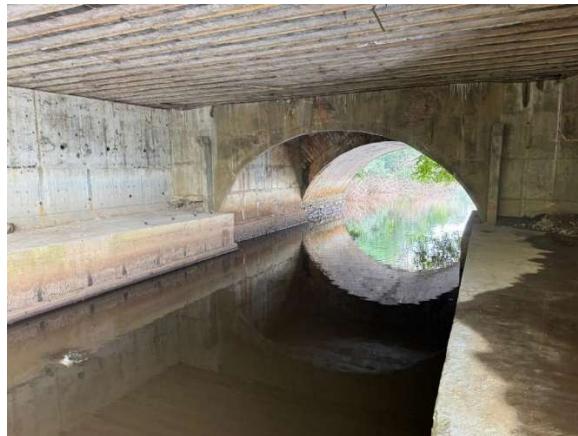
Photo 1 - View from the soffit of the deck

No damage to the main structural elements of the bridge was observed. On the embankment approaching the left abutment, a localized pavement collapse caused by embankment washout occurred; this had already been repaired (embankment refill) at the time of the site inspection.

- Visual inspection of the bridge stability (deck and piers) after each major flood event(s).
- It is recommended to consider adopting a Bridge Management System (BMS) to compare inspection results over time, monitor the bridge's condition, assess bridge reliability indices and plan interventions, or further investigations, accordingly.

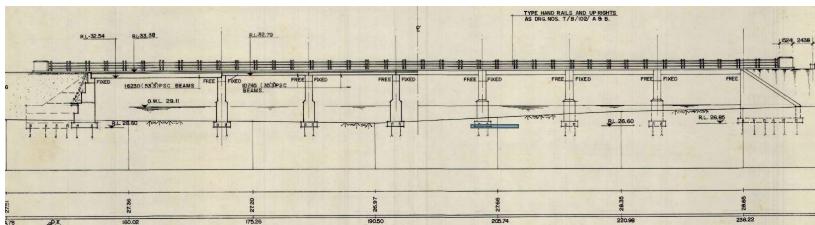
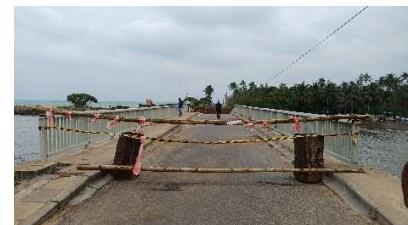
*Photo 1 - Longitudinal profile from construction drawings (left)- View of the Bridge from the deck (right)*

During the flood event, the bridge suffered severe structural damage with the collapse of the sixth and seventh spans. The failure was caused by the collapse of an intermediate pier, while the adjacent pier that remained in place shows residual rotation and settlement due to intense foundation scour. Based on the measurements carried out and presented, the local scour depth appears to exceed 7 m.

The main cause of the damage is attributable to foundations that are effectively shallow and founded on alluvial material, in contrast with the design documents that indicated foundations anchored into rock. The absence of scour protection measures facilitated the progressive erosion of the riverbed, leading to loss of support, pier rotation, and overall structural instability.

- Safe removal of the damaged part of the bridge and debris.
- A rapid assessment of the bearing capacity and scour stability of the existing foundations should be carried out, based on updated bathymetric data to evaluate the safe reuse of the remaining structure with a temporary solution for the collapsed section
- Install a temporary Bailey bridge at spans 6-7 of the bridge, considering the reuse of the existing undamaged spans, subject to a preliminary structural condition assessment.

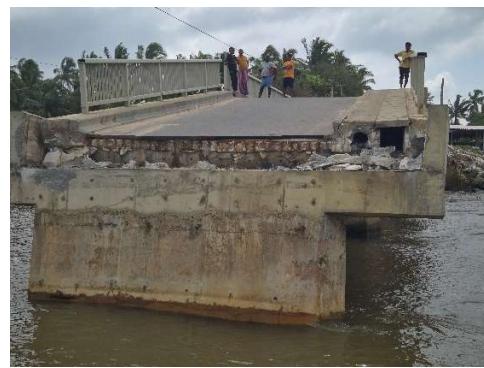
*Photo 2 – View of the bridge section affected by the collapse*

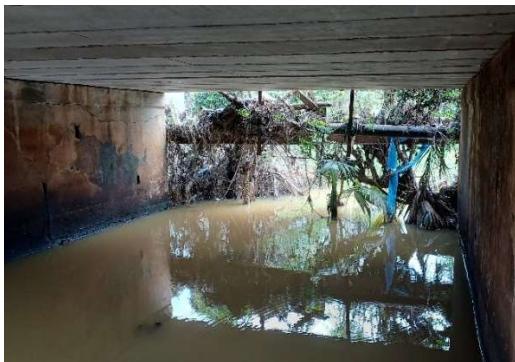
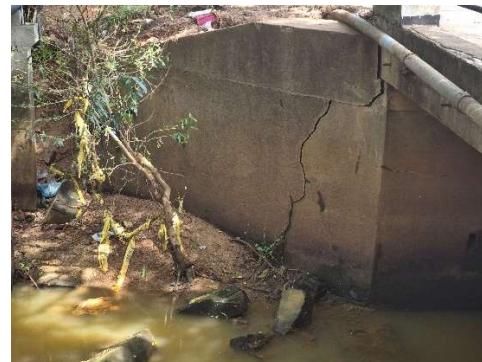
The inspection identified critical issues linked to both the torrential hydraulic behaviour of the watercourse and the structural configuration of the bridge. The accumulation of vegetation and debris within the channel significantly obstructs flow during the flood. Flood levels were estimated to reach approximately 1.2 m above the level of the deck. From a structural perspective, the absence of a cast-in-place reinforced concrete slab over the PSC beams prevents the beams from working together effectively as a single structural deck. The abutments and the wing walls of the downstream bridge are cracked.

*Photo 2 – View of the bridge deck soffit and riverbed with obstructive debris accumulation and damage to left abutment (left), and visible cracks between abutments and wing walls (central, right).*

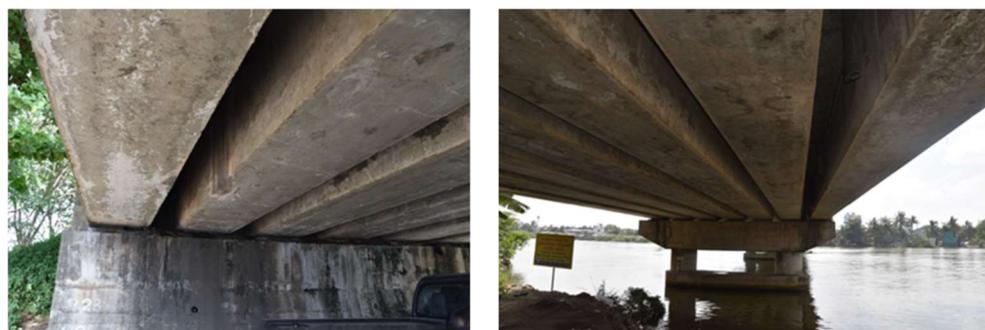
From a structural point of view, no problems or damage due to the flood were detected. The main beams do not have transverse beams at the supports. The joints between adjacent spans are very small, and traces of moisture and efflorescence can be seen on the surfaces of the beams. There are only general considerations regarding the bridge management and design approach for future design.

*Photo 2 – Detail of underside of the deck and abutment (left) and pier (right).*

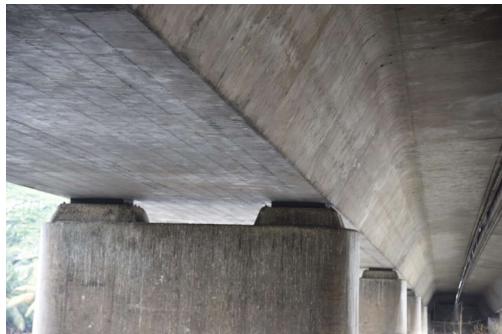
From a structural point of view, no problems or damage due to the flood were detected. On the third pier from the abutment in the middle of the river, subvertical cracks were reported (by a fisherman). A drone inspection revealed a crack on both sides, the total length of the various sections being a few meters, but the width could be estimated as 0.3÷1 mm. It should be noted that the concrete cover used for the piers is 75 mm, so there may be shrinkage issues. The end of the deck face isn't inspectable, and the joints between beams and abutments is rather small; some trace of humidity and efflorescence are visible on the external surfaces of the beams.

Photo 2 – Detail of the bearing system

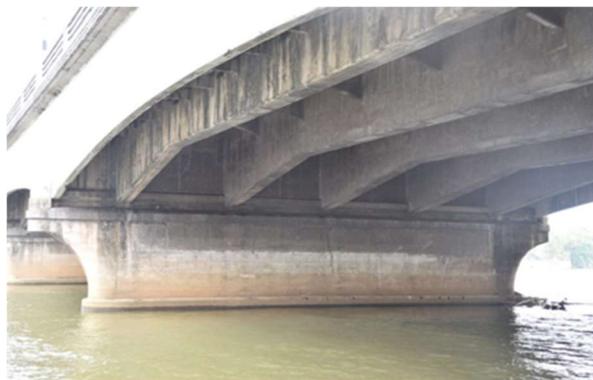
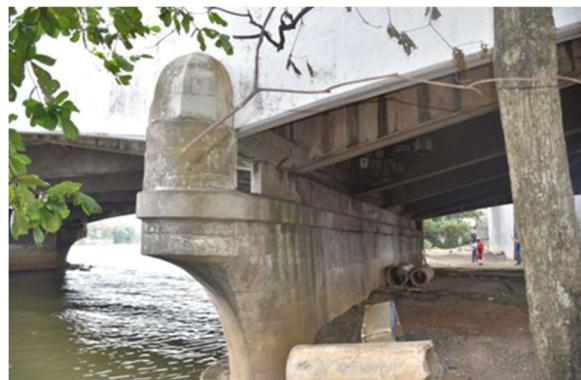
From a structural point of view, no problems or damage due to the flood were detected. The Gerber saddles are located on the span adjacent to the incised riverbed. Although direct inspection of these saddles is not possible, there are no visible indications of structural damage at this location. Some lack in the concrete cover has been identified, resulting in areas where reinforcing bars are exposed. This condition can potentially compromise the durability and integrity of the structure over time.

*Photo 2 – Detail of the main girders (left) and pier cap (right).*

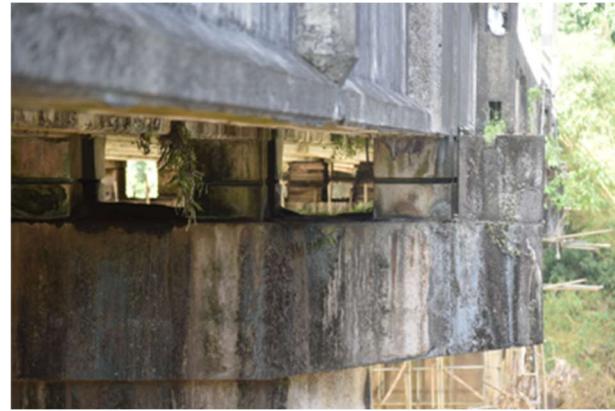
*Photo 3 In the background the work (temporary bearings) on the central pier cap and on the right side the scaffolding with debris*

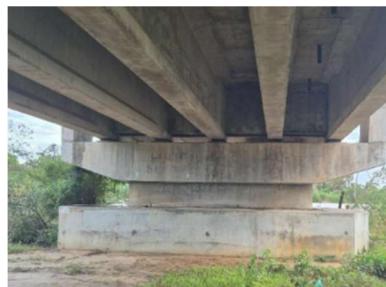
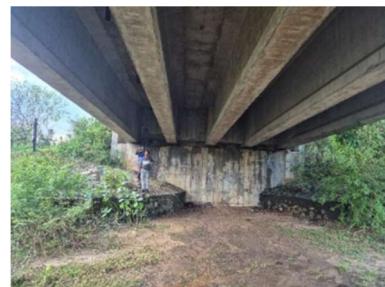
Photo 2 - Details of the structure

The visual inspection did not reveal any visible structural damage due to the recent flood event; however, the presence of debris obstructing the expansion joints was observed. There are only general considerations regarding bridge management.

- Cleaning bridge joints.
- Visual inspection and, if necessary, cleaning/repairing of the drainage ducts along the deck.

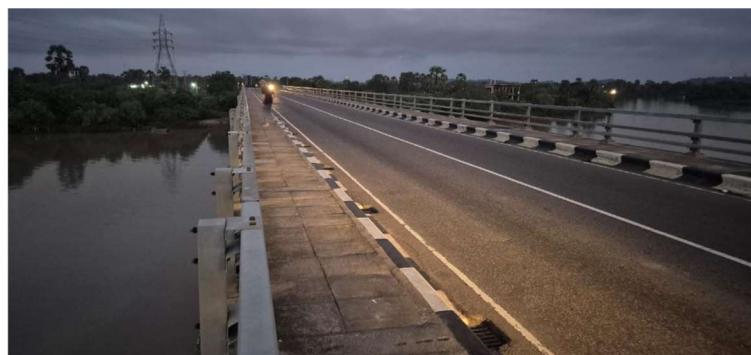
*Photo 1 – Overall view of the structure*

- Detailed visual inspection of piers, beams, deck, and abutment walls.
- Visual inspection to assess the overall current condition of the bridge deck, with reference to the pavement, deck drainage ducts, and expansion joints.
- Where necessary, cleaning and repair of the drainage system, and execution of asphalt repair or resurfacing works should be considered.

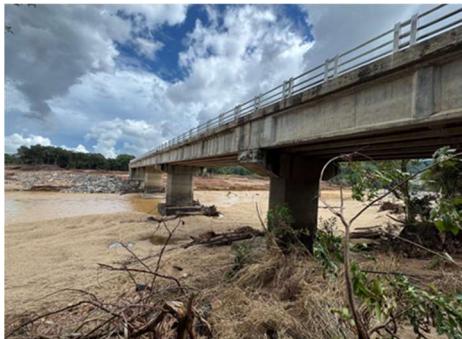
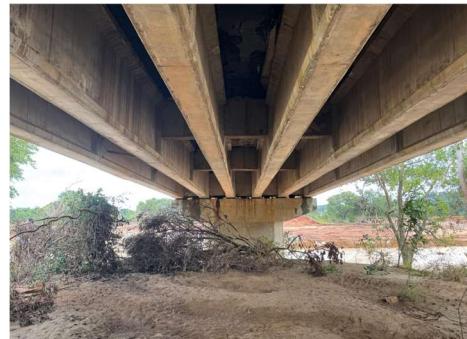
*Photo 1 - Overall views of the bridge.*

From structural point of view, the bridge is in good condition, but one of the abutments has its upper part of the foundation completely exposed due to the scour (at least for 2 meters). The flood arrived from the dam, has been concentrated on the body of the embankment behind the abutment, therefore the entire embankment was swept away by the current for several dozen meters, destroying the entire roadway above. The cause of this failure can be found both in the flow rate released by the dam during the event, and in the direction of the water flow released by the dam, which does not appear to be aligned with the bridge, unlike the original riverbed. Traces of moisture and efflorescence can be seen on the surfaces of the beams and the lowerside of the deckslab and on the piers cap.

- Removal of debris around the piers and abutment
- Bathymetric survey of the river cross-section in the proximity of the bridge piers and abutment to assess erosion processes. The area subject to scour needs to be filled and subsequently, the riverbed and the banks must be protected with a riverbed defense system (riprap- see the Additional documentation).
- Visual inspection of the support devices and deck joints, with recording of the results (particularly if any defect is found), to monitor their evolution over time;
- Visual inspection and, if necessary, cleaning/repairing of the drainage ducts along the deck Recognition of actual condition of the foundations of the piers (entity of scour).

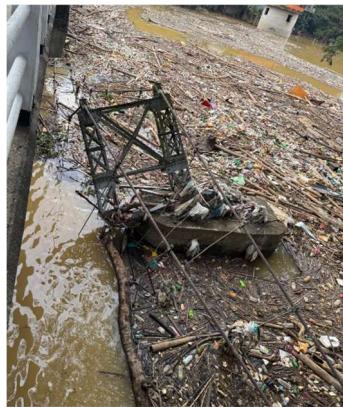
There are no structural issues detected in the road bridge due to the flood, while the pedestrian bridge has collapsed. The joints between adjacent spans are very small, and traces of moisture and efflorescence can be seen on the surfaces of the beams.

It is urgent to remove the rubble of the pedestrian bridge collapsed in the river, as it constitutes a barrier to the passage of water.

Photo 2 – Collapsed pedestrian bridge.

- Removal of debris around the piers and abutments, and the debris of the collapsed pedestrian bridge; paying attention to recover the less damaged components.
- Bathymetric survey of the river cross-section in the proximity of the bridge piers and abutment to assess erosion processes. The area subject to scour needs to be filled and subsequently, the riverbed and the banks must be protected with a riverbed defense system (riprap- see the Additional documentation).
- Visual inspection of the support devices and deck joints, with recording of the results (particularly if any defect is found), to monitor their evolution over time;
- Assess the current condition of the bridge deck pavement and undertake repair or resurfacing works as necessary.

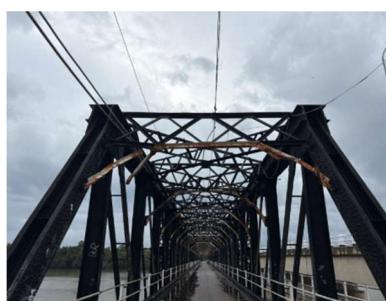
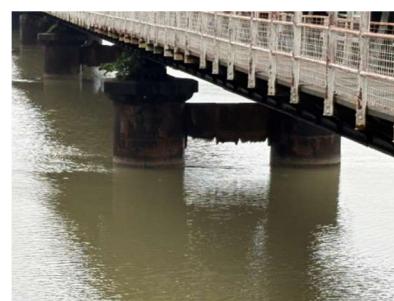
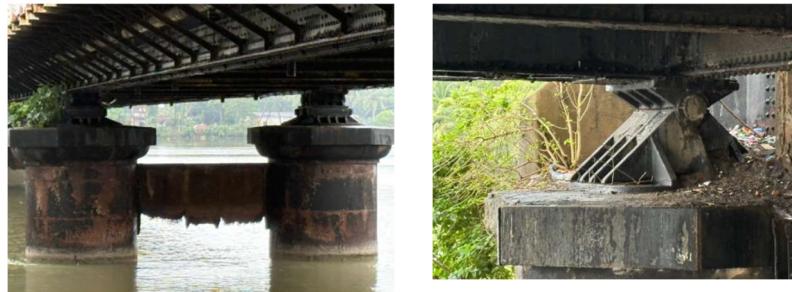
*Photo 2 - Details of the structure.*

The visual inspection did not reveal any visible structural damage due to the flood event, although severe damage is observed in the diagonal bracing members, consisting of back-to-back L-shaped steel sections. The damage includes both buckling of members and fracture of individual elements.

The buckling of the diagonal bracings is mainly attributed to the transit of heavy trucks carrying large containers in the past. The expansion joints are also damaged, primarily due to inadequate maintenance and prolonged exposure to heavy vehicular traffic.

*Photo 2 – View of damage to the diagonal bracing members and general conditions of the abutment*

- Repairing of the damaged steel members (buckled and fractured) and painting of all the members for corrosion resistance.
- Cleaning and repair of the drainage system, and execution of asphalt repair or resurfacing works.
- Cleaning bridge joints.
- Cleaning of the riverbed near the bridge abutments

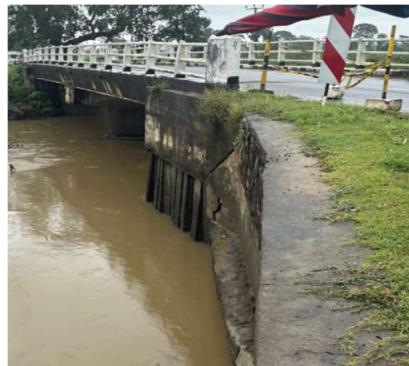
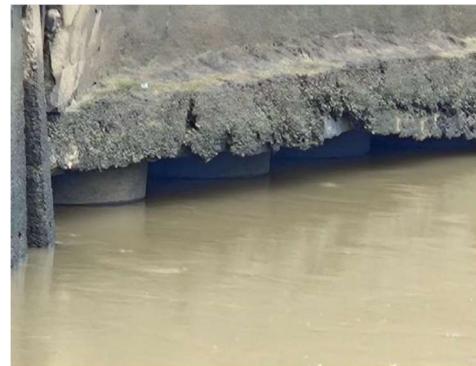
The wing wall of the downstream abutment on the left bank has pronounced cracking (Photo 2, left), indicating progressive erosion and instability created by scouring (Photo 2, right). The interface between the embankment and the abutment shows evidence of differential movement, with visible longitudinal and vertical cracking (Photo 2, left).

Photo 2 - Damage to the wing wall

- Detailed inspection of damaged pier with measurement of the potential tilt;
- Monitoring, warning with alert leading to bridge closure in case flood level thresholds are exceeded.
- Assess erosion processes around the abutment including a bathymetric survey of the river cross-section in the proximity of the bridge piers and abutment.
- Repair the abutment wing wall by restoring the plain concrete connection-wing wall at the top.
- Cleaning of bridge joints.

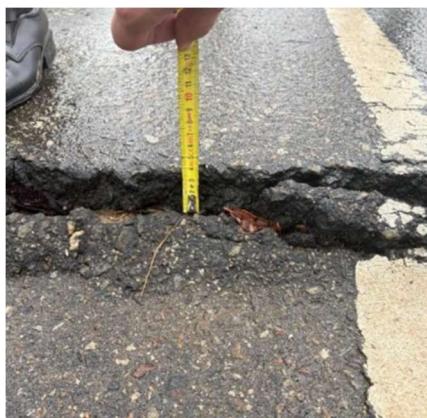
At the foundation level, concrete degradation and scouring were observed near the waterline, suggesting the presence of erosion. The intermediate pier seems tilted, likely associated with rigid ground movement and foundation instability. On the embankment approaching the left bank abutment of the bridge, a localized pavement settlement is caused by washout of soil occurred. A drone survey for 3D-modelling was carried out during the assessment.

Photo 3 - Damage in proximity of the abutment (left) - 3D-modelling through drone survey and assessment of the damaged area (right)

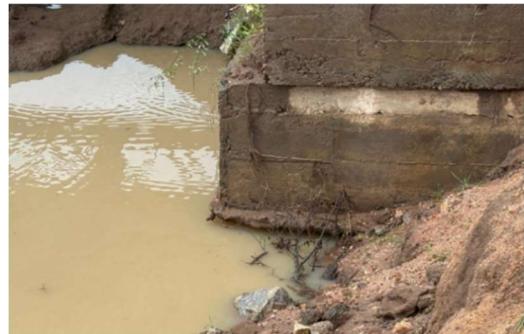
The flood caused severe structural damage to the abutments supporting the Bailey bridge constructed in 2010. Consequently, as a temporary solution, the bridge span was increased by relocating the abutments toward the embankment. The hydraulic cross-section in the vicinity of the bridge remains partially obstructed by the remaining of the abutments and embankments of the original bridge.

*Photo 2 -Damage to the abutments*

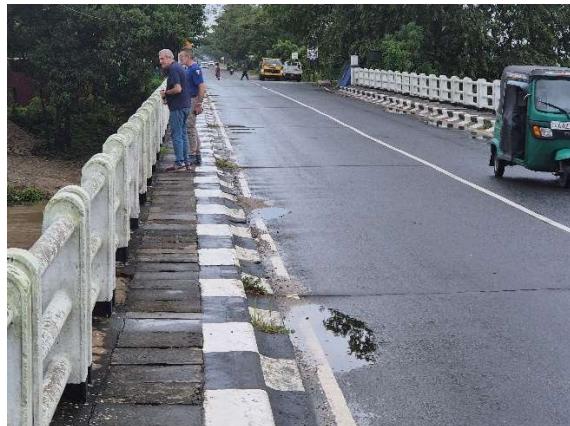
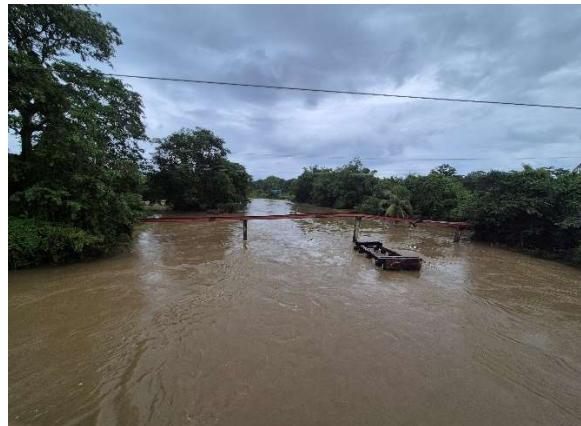
The visual inspection did not reveal any visible structural damage caused by recent flood event; however, debris was found obstructing the drainage system and joints. The river morphology upstream and downstream of the bridge section has been altered by the passage of the flood.

Photo n.2 - view of the bridge deck (left) and downstream of the bridge (right)

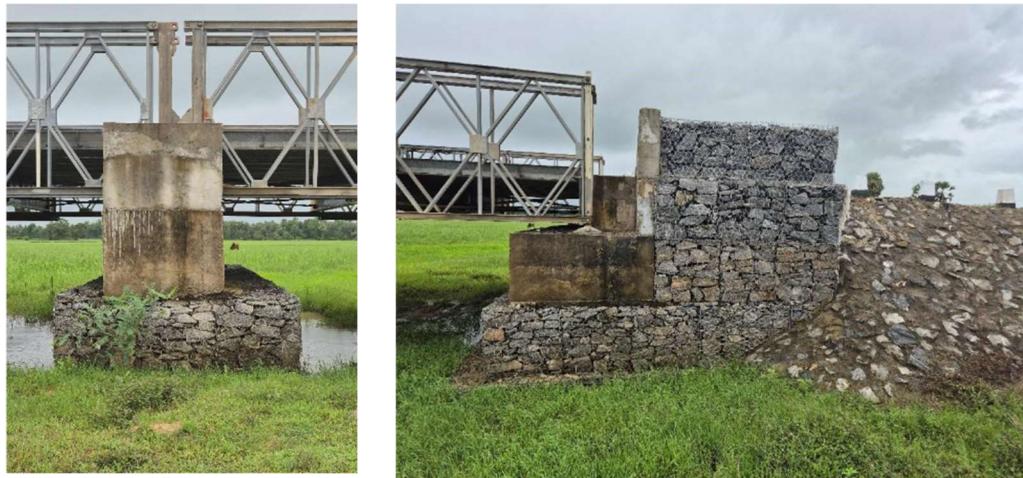
No structural damage was observed due the flood, however, a deformation of the rock caisson supporting the concrete cap was noted, most likely occurring in the initial phase, during the construction of the RC block. In any case, the bridge configuration permits potential differential settlements between the abutments and the central pier. The adopted clear span and the foundation system seem to be appropriate for the smooth flow of the river water.

*Photo 2 – Views of the rock caissons and abutments foundations*

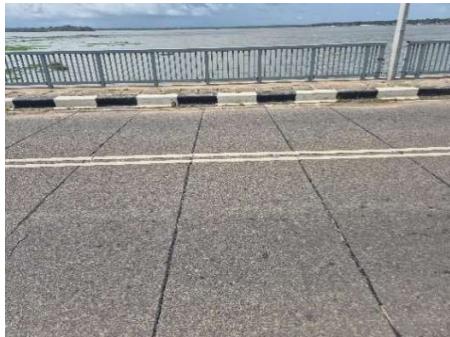
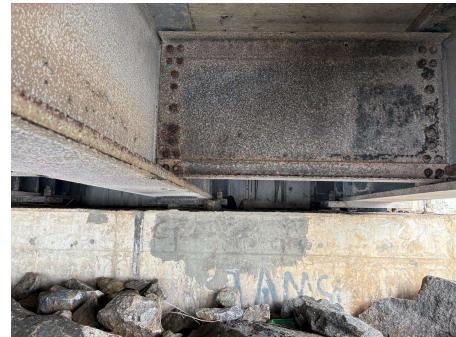
The visual inspection did not reveal any visible structural damage due to the flood event; however, non-structural damage was observed. The cracks observed in the asphalt, in proximity to the abutment bays, are induced by beam vibrations caused by the heavy dynamic traffic loading. The joints observed in the asphalt, located in proximity to the abutment bays, are intentionally provided to accommodate beam vibrations and excessive span deformability in these specific areas, thereby preventing generalized

cracking of the pavement under dynamic traffic loading. Severe corrosion is affecting the bridge, particularly along the downstream lateral pedestrian parapet walkway.

*Photo 2 – Asphalt joints accommodating surface vibrations (left); corrosion of the deck steel frames (centre); corrosion of the pedestrian parapet (right).*

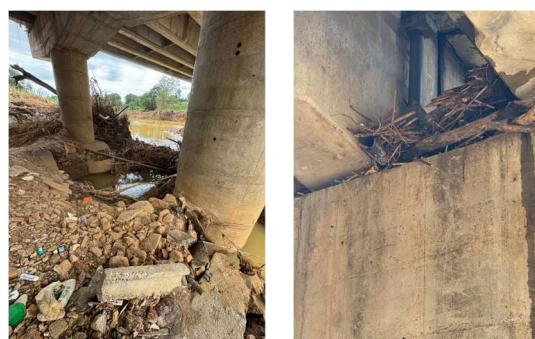
The bridge does not present structural issues, although the water level has risen above the deck. However, the condition of the bearings will need to be checked. The piers show clear signs of scour and debris accumulation (also close to bearings). Traces of moisture and efflorescence can be seen on the surfaces of the beams and the lowerside of the deckslab (specially the oldest one) and on the piers cap.

*Photo 2 – debris on the foundation (left) and flow debris close to the bearings (right).*

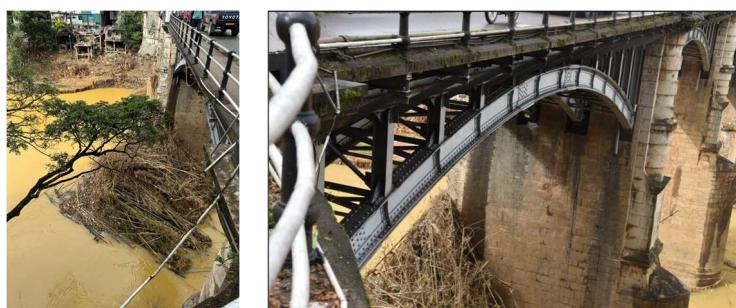
The bridge does not present structural issues. Signs of erosion and scour can be seen at one of the two abutments (the one on the right of the riverbed).

Photo 2 - Lateral view of the bridge (left) and detail of one of the four steel arch (right).

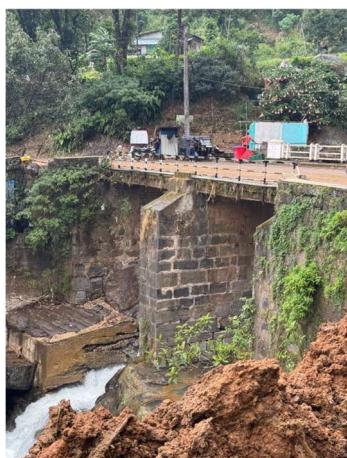
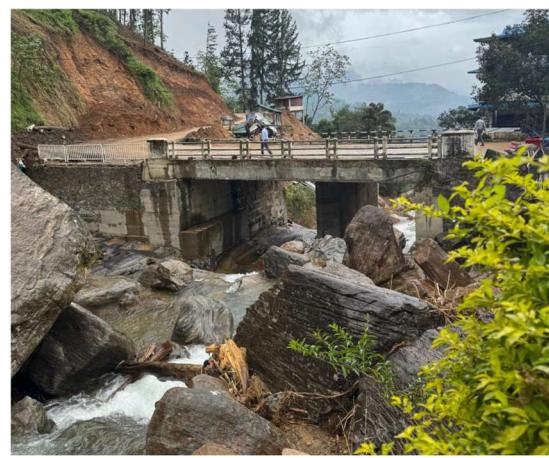
Photo 1 - Overall view of the bridge. Downstream (left) and upstream (right).

- As previously mentioned, an intervention is already scheduled for this bridge. The primary objective of this intervention is to replace the existing old deck by a new structure similar the existing one upper stream removing the existing central pier. This solution is specifically intended to enhance the bridge's hydraulic performance, ensuring improved waterflow management under both ordinary and extreme conditions.
- Assess the current condition of the bridge deck pavement and undertake repair or resurfacing works as necessary.

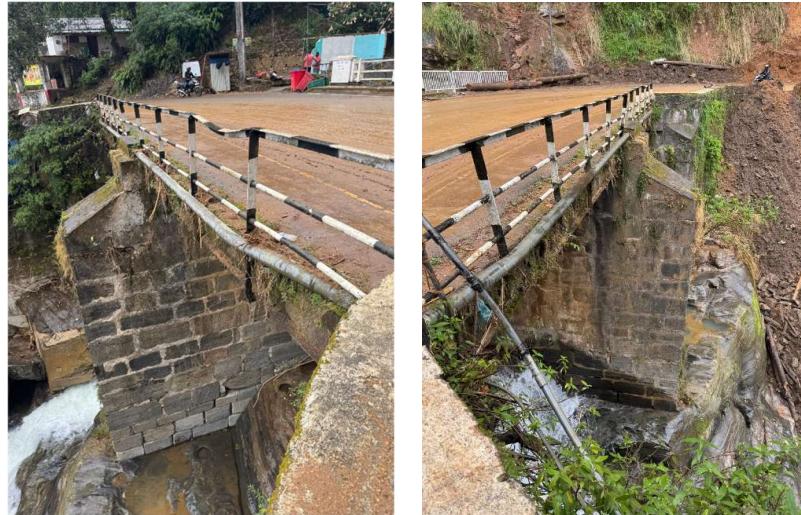
The area around the bridge is affected by a very significative landslide event, however the bridge itself does not present particular structural issues due to the landslide or scour, but it's evident that the reduced dimension of the minimum span length, equal to 7,5 m, and the consequent presence of the central pier, represent an obstacle to the waterflow, especially during no-ordinary events, due to particular condition of the site, as described above

*Photo 2 – Detail of the old central pier. Left side (left) and Right side (right).*

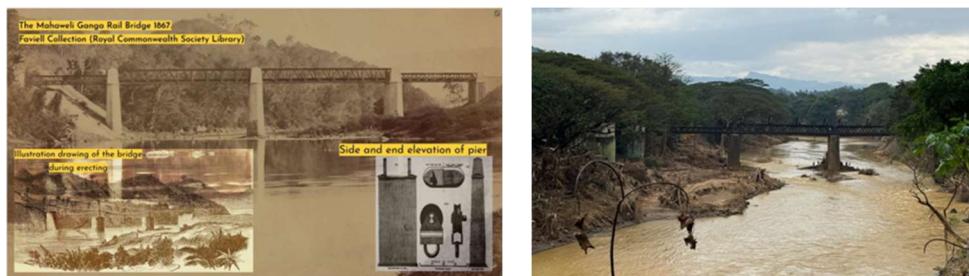
*Photo 1 - Overall view of the original (left) and actual structure (right).*

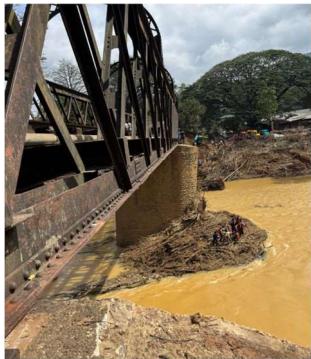
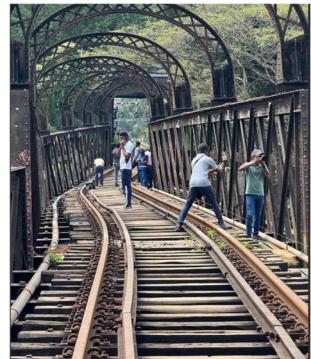
During the flood event, the bridge experienced significant central pier tilting and settlement due to scour at the foundation. The damaging mechanism can be attributed to localized foundation scour combined with high flow velocities, debris impact, uplift effects, and interaction with the river flood. The water, accelerating around the pier, generates bottom vortices that can remove bed material (gravel, sand, silt).

Due to the extraordinary flood of the river, an excavation (scour) has been formed at the base of the central pier, lowering the upstream foundation level and causing it to rotate rigidly of about 7°, resulting in a horizontal displacement of approximately 1.8 m and a vertical settlement of 1.0 m of the top of the central pier. Consequently, the two girders supported on the pier altered their geometry by rotating and lowering at the extremity. This led to the out of service for the line.

Effectively, further erosion/undermining phenomena could compromise the structural stability of the pier and therefore, of the bridge.

Photo 2 – Rotation of the pier (left), deviation of the rail (central and right).

- Removal of debris around the piers and abutments;
- Survey the current geometry of the riverbed at the location of the existing foundations and for at least 10 m upstream and downstream;
- Reconstruct the geotechnical profile of the foundation soils at the river crossing;
- Verify the current condition of the pier foundation and assess the extent of erosion around its entire perimeter;
- Evaluate the residual capacity of the piers, starting with the central pier, using standardized procedures.

- Geometric and structural restoration of the foundations (possibly using micropiles), of the central pier and, subsequently, proceed with a rotation of about 7° with respect to the horizontal axis (up to the original position) to restore the verticality of the pier. This delicate operation must be carried out ensuring that the entire original foundation moves as a single unit, without damage and/or disconnections (a perimeter bracing of the foundation and the original shaft with steel or concrete elements may be helpful). During the movement of the shaft, the steel beams must be fixed to the pier cap with bidirectional connections. After the rotation, firmly connect the shaft to the reinforced foundation, consolidate the shaft, and then complete the intervention by restoring and/or reconstructing the pier cap.

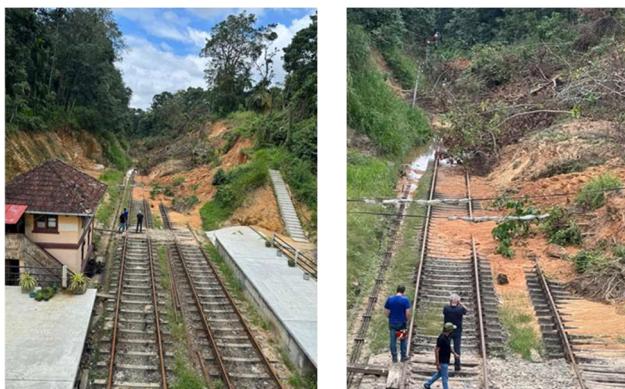
Landslide affecting the railway track near the Station. Three different points were observed. The first one closes to the station, the others around 500 mt. from the main building. The cross section of the railway in these areas is in trench. The conditions of the sites are stable (only debris over the track).

*Photo 1 - Overall views of the site.*

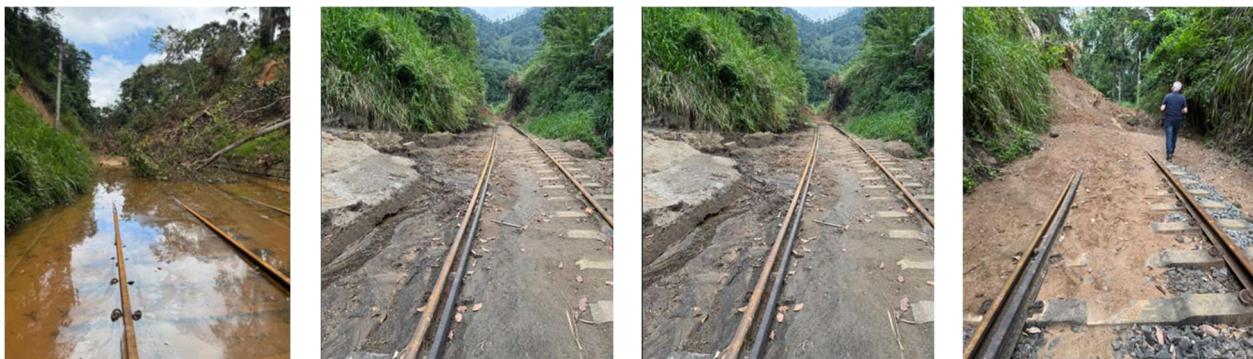
A landslide event caused by heavy rainfall resulted in the detachment of soil and rock material from a steep slope adjacent to the railway line. The saturated ground lost stability due to prolonged precipitation, triggering a mass movement of debris downslope. The displaced material, consisting of mud, stones, and vegetation, accumulated on the railway line (over track bed), partially obstructing the track and forbidding train operations.

Photo 2 – Detailed views of the site.

- Removal of debris from the railway track and adjacent areas, with particular attention to unstable soil sections and/or trees.
- Check and eventual replacement of Railway Track Equipment crushed or damaged.

- Check of stability conditions in transversal and longitudinal direction of slope and, if necessary, re-profiling the geometry of the slope.

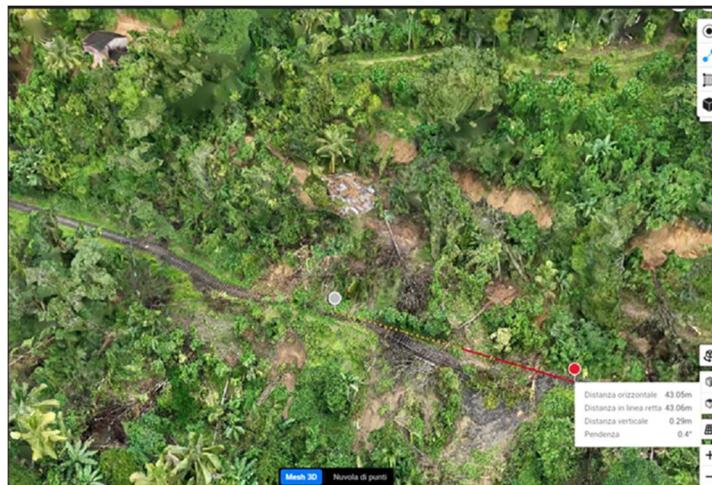
*Photo 1 - Overall view of the area (drone image with possibility of extracting measurements).*

Three landslides triggered by intense and prolonged rainfall have caused a deep subsidence that affected the entire railway embankment for several dozen meters. As the embankment shifted, entire sections of the ballast slid downhill, leaving rails and sleepers suspended in the air in three distinct sections, each 15 to 30 meters long. In one of these sections, a rail joint failed, disjointing the track, and breaking several sleepers. These conditions make rail traffic impossible. Furthermore, a fourth landslide occurred near the entrance to Tunnel No. 9, partially obstructing the railway track and causing water to pool from the tunnel, which slopes steadily toward the entrance to the landslide.

- Rehabilitation of the railway line in areas where the embankment and the track have slid downhill can be accomplished by:
  - a) rebuilding the embankment with prior consolidation of the foundation soil,
  - b) if option a) is not technically possible or economically convenient, crossing the landslide with a new railway bridge.

Intervention type a) can be considered for cases where the track elements are not damaged. It involves removing the landslide soil and the misaligned track, stabilizing the support surface, and rebuilding the new embankment in layers, followed by installation of the railway superstructure.

Intervention type b) may be necessary in landslides where the track has broken. To build a bridge, the landslide embankment and the misaligned track must be removed, abutments must

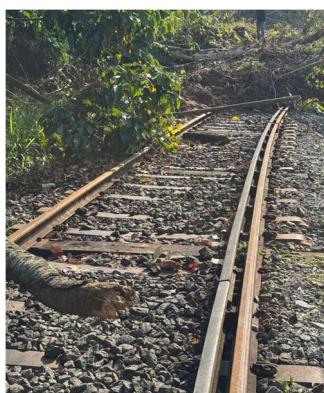
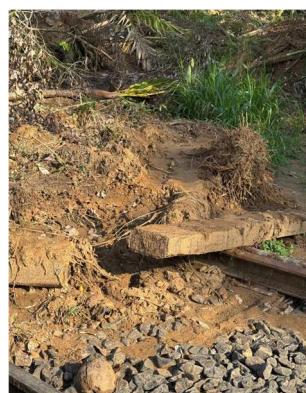
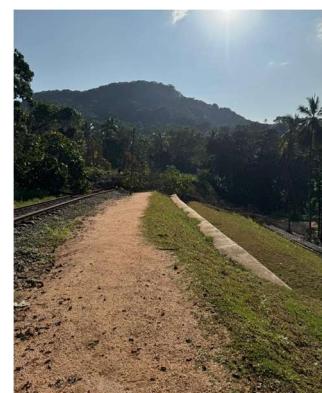
A landslide event caused by heavy rainfall resulted in the detachment of soil and rock material from a steep slope adjacent to the railway line. The saturated ground lost stability due to prolonged precipitation, triggering a mass movement of debris downslope. The displaced material, consisting of mud, stones, and vegetation, accumulated on the railway line (over track bed), partially obstructing the track and forbidding train operations.

In the first site observed (the first coming from Rambukkana), the landslide has occurred only upslope of the railway and not downslope, because a consolidation work with gabions and water management had recently been completed. A tangible sign of the effectiveness of this intervention. Another landslide also occurred on the mountain side.

*Photo 2 – Detail of landslide affecting railway tracks (left and center) and existing stabilization intervention (right)*

- Removal of debris from the railway track and adjacent areas, with particular attention to unstable soil sections and/or trees.
- Check and eventual replacement of Railway Track Equipment crushed or damaged.

- Check of stability conditions in transversal and longitudinal direction of slope and, if necessary, re-profiling the geometry of the slope.

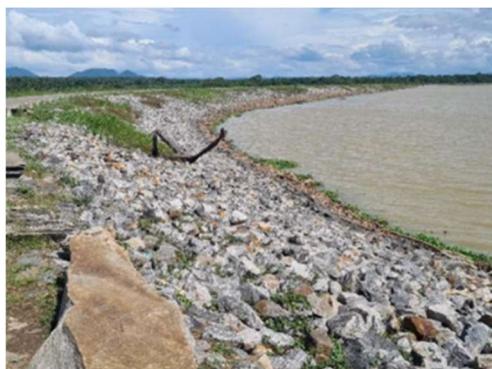
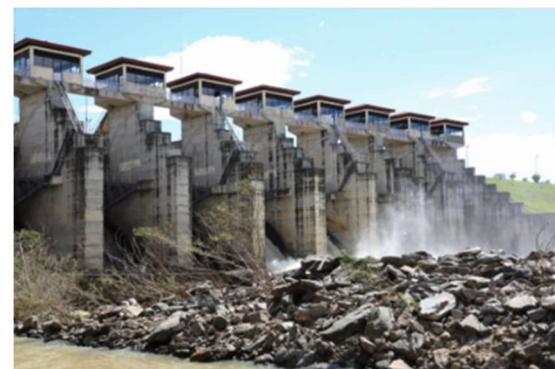
*Photo 1 - Overall view of the structure: left) earth dam portion, right) concrete dam portion*

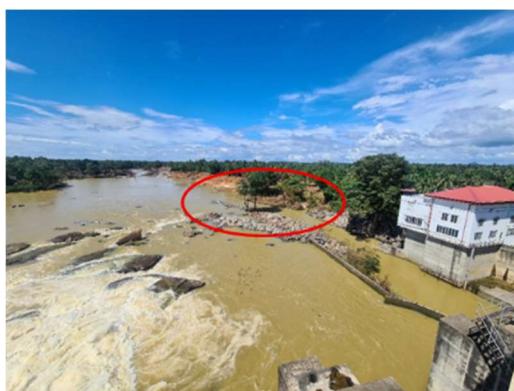
During the flood, the high flood level has been overcome, and all the surface gates have been fully opened, reaching a flow rate of 3200 m<sup>3</sup>/s. This water release has caused damage downstream both to the riverbed and its banks (especially on the right bank) and to irrigation canals up to 1 km distance from the dam. Evacuation was ordered only for people within 1 km distance downstream.

*Photo 2 – View of the riverbed with indication of the damaged right bank*

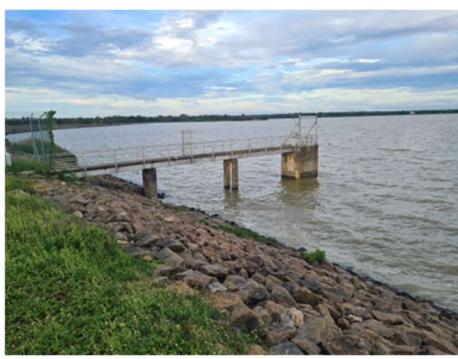
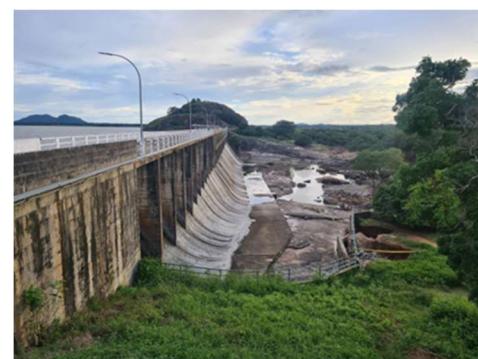
*Photo 1 - Overall view of the structure.*

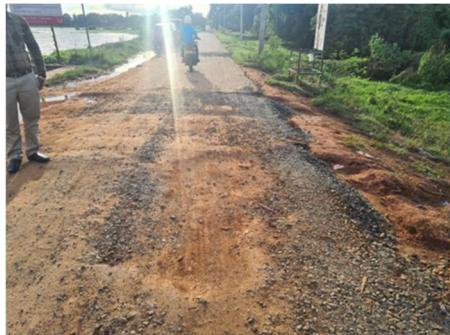
During Cyclone Dithwah, the peak flood inflow (1,000-year) was exceeded, resulting in the opening of 28 of the 30 spillway gates. Two gates were not opened due to a malfunction of the operating system. As

observed during the site visit and reported by the on-site technicians, no damage to the dam structure was detected, either in the earth or concrete parts. However, the natural side saddle was overtapped and suffered significant damage due to material erosion and removal.

*Photo 2 – View of the natural saddle surface erosion*

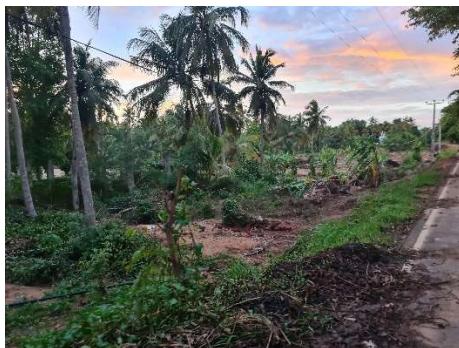
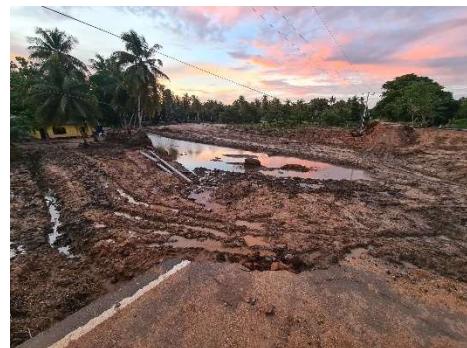
In addition, damage was observed in the downstream riverbed, including houses being washed away and damage to local access roads. During the technical site inspection, several critical issues not directly related to the flood event were also identified. These include widespread deterioration of the pavement covering the crest of the concrete section of the dam, as well as the malfunction of the acoustic warning system intended to be activated in the event of spillway gates opening.

*Photo 1 - Damage in the downstream riverbed.*

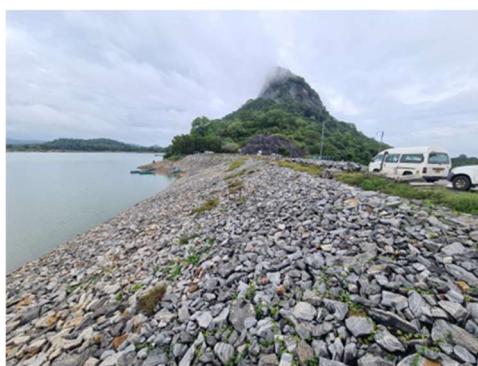
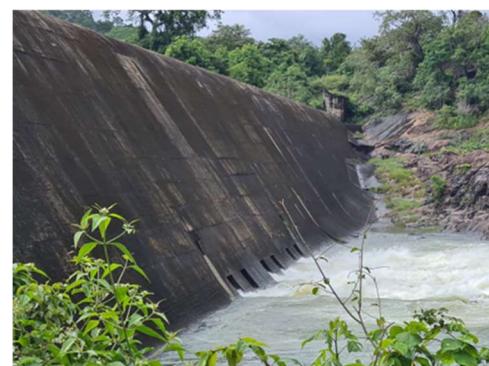
*Photo 1 - Overall views of the dam.*

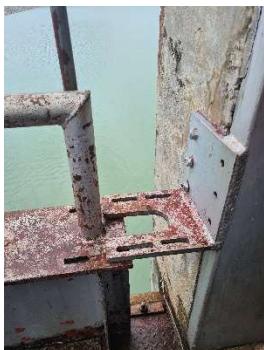
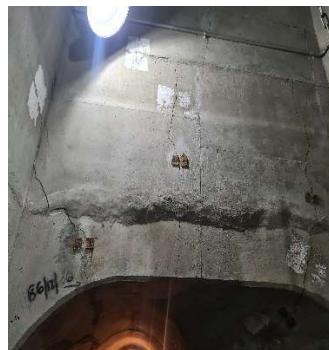
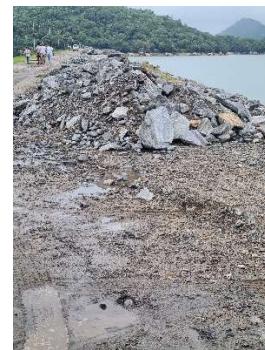
During the technical site inspection, several critical issues not directly related to the flood event were identified. These include widespread deterioration of the pavement covering the crest of the earth dam and several cracks in concrete structure, both in the sluice tower and the spill structure.

The sluice tower has extensive cracking in the portion that is permanently submerged, which therefore could not be directly observed. A relative displacement between the tower and the access walkway was also detected, which has been attributed to a slight rotation of the tower itself. Over the years (since 1990s), investigations and crack-filling interventions have been carried out; however, the evolution of the cracking pattern is still ongoing. Crack patterns and investigations were, however, presented to the team by the Irrigation Department during a meeting before the site visit. The reported causes of cracking, such as concrete ageing or reinforcement corrosion, appear unlikely in this case, particularly given that the cracks are located in permanently submerged areas where oxygen availability is limited, and corrosion processes are inhibited. Investigations instead indicated the presence of alkali-sulphate reaction products along the cracks. This reaction is known to promote the formation of ettringite, leading to volumetric expansion of the concrete and associated cracking. The presence of water, as in the current conditions, is known to accelerate this reaction. The extent and asymmetric distribution of cracking on one side of the tower may also have contributed to the observed rotation of the sluice tower.

Regarding the spillway structure, cracks were observed both on the concrete surfaces (from a distance) and within the gallery at the base of the structure. In the latter, water seepage was also detected. The technical staff reported that cracks in the concrete are also present at the outlets of the bottom outlet. The technical staff are currently awaiting a design proposal for remedial works addressing both the sluice tower and the spillway structure. In addition, stockpiles of rock blocks were observed on the crest, intended for use in ongoing rehabilitation works aimed at restoring the riprap protection on the upstream face.

Photo 2 – Observed critical issues

It is further suggested to assess the mechanical properties of the foundation soils and the spillway concrete, and to perform stability analyses of the concrete dam. It will be beneficial to seal the cracks and to increase the weight of the spillway structure, which appears to be relatively slender, through a possible strengthening intervention on the downstream face.

With regard to the condition of the sluice tower, the usefulness of constructing a new intake structure for the diversion works and installing a pipeline that does not pass through the earth embankment is acknowledged. Furthermore, to prevent damage to the pipeline currently crossing the earth dam in the event of a potential tower collapse, it is considered advisable to relocate the intake inlet further upstream, ensuring an effective connection to the existing pipeline. In this case, downstream flow regulation shall be provided where not already present. However, it will be necessary to infill the existing tower with suitable material to protect the new pipeline configuration in the event of tower collapse or controlled demolition. If strengthening of the sluice tower is pursued, the causes of the cracks and tower rotation must be clearly understood to enable an effective structural strengthening intervention.

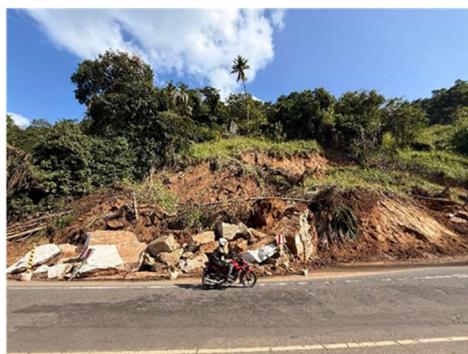
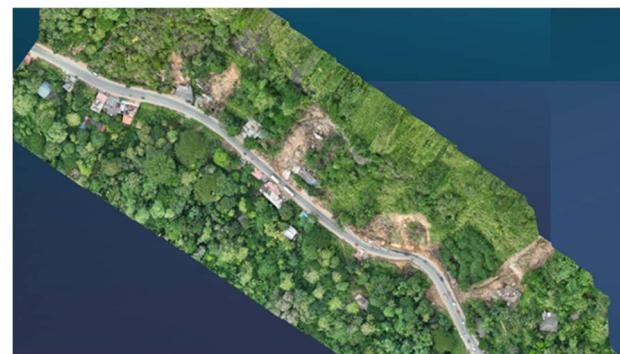
*Photo 1 - Overall views of the landslides.*

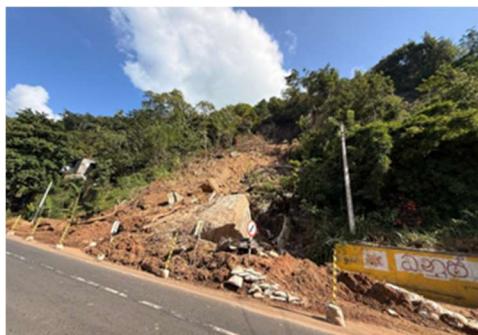
The slope along the A1 Road was affected by several landslides along a stretch of almost 100 metres, which damaged buildings and businesses and caused the death of six people. These localised landslides were caused by the collapse of large boulders from a rocky substrate above a layer of gravelly matrix material of varying thickness. They were triggered not only by heavy rains that eroded the base, but also by the fracturing of the rock layer due to the action of the roots of dense shrub vegetation. A drone flight conducted by Mr. Stefano Melosi confirmed the widespread landslides in the area. Clearing works were underway on a section of the road.

*Photo 2 – Rockfall.*

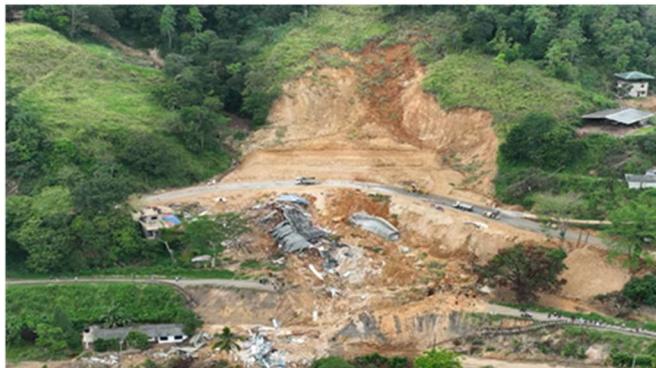
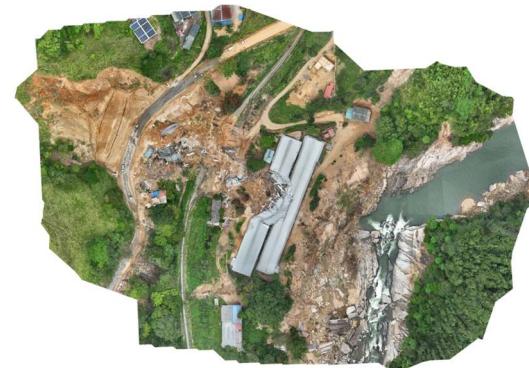
*Photo 1 – Overall view of the landslide*

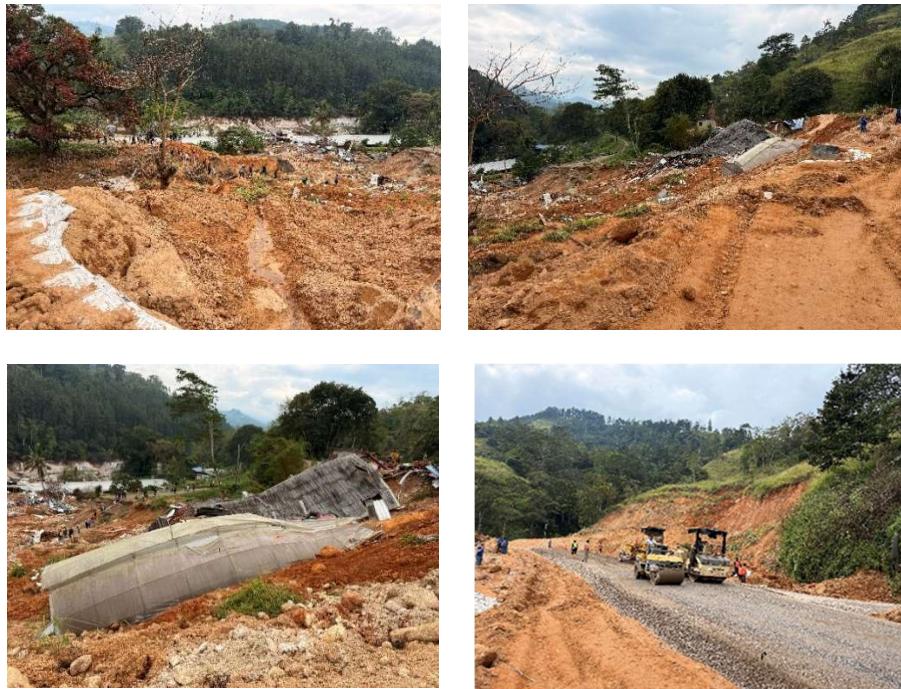
The landslide consists of a debris flow that covered and destroyed approximately 180 m of the AB13 roadway and irreversibly damaged about 140 m of the railway line, causing disruptions to local transportation. In addition to the road and railway line, the landslide destroyed commercial properties, including a carpentry shop, a farm, and a factory, as well as causing damage to residential buildings. A drone flight conducted by Mr. Stefano Melosi confirmed the extension of the landslide. Work is currently underway to restore the roadway while the railway line remains interrupted.

*Photo 2 – Detailed views of the landslide*

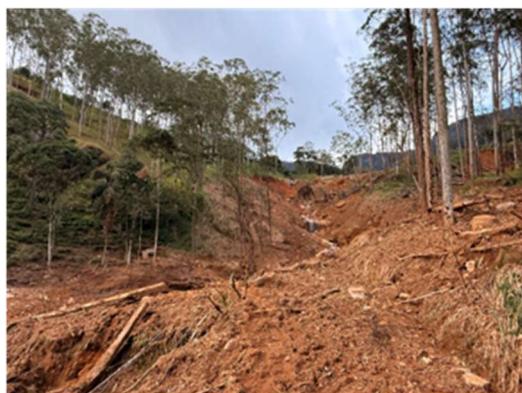
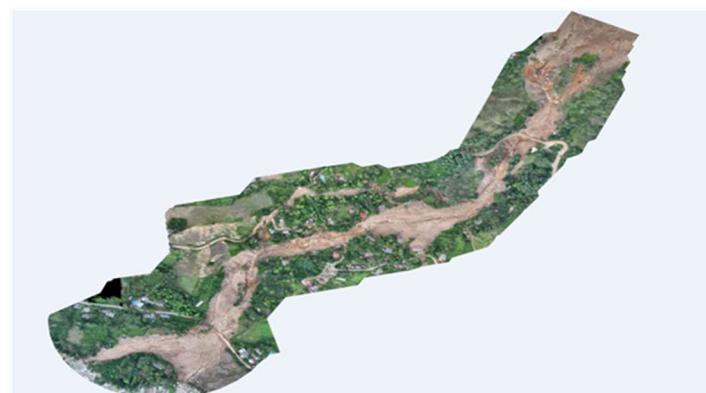
*Photo 1 - Overall view of the landslide.*

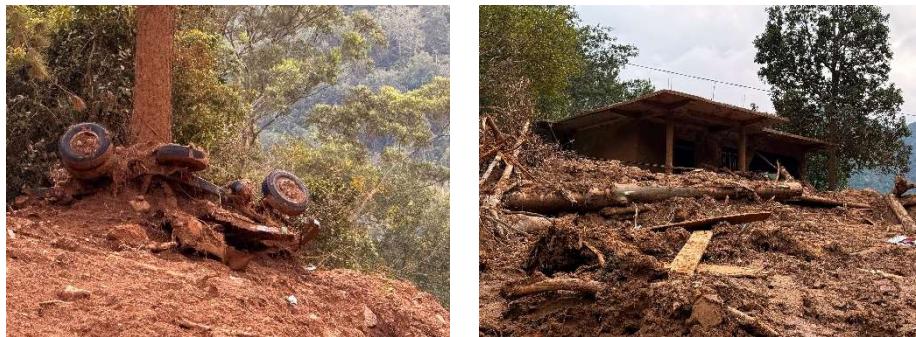
The landslide consists of a debris flow (estimate volume of about one million mc) which covered the roadway, destroyed about 10 buildings and caused 20 fatalities (10 bodies found). Additionally, the landslide affected 43 buildings and the following roads: i) Kandy-Nuwara Eliya Road (AA005) for 0.045 km, ii) Ramboda-Sangilipalama Road (B612) for 0.11 km, and, ii) Tawalantenna-Talawakele Road (B412) for 0.1 km.

Urgent measures were taken to clear the road surface to allow vehicles passage, although the entire route remains affected by widespread damage, making travel difficult. A drone flight conducted by Mr. Stefano Melosi confirmed the the considerable extent of the landslide.

*Photo 2 – Detailed views of the landslide.*

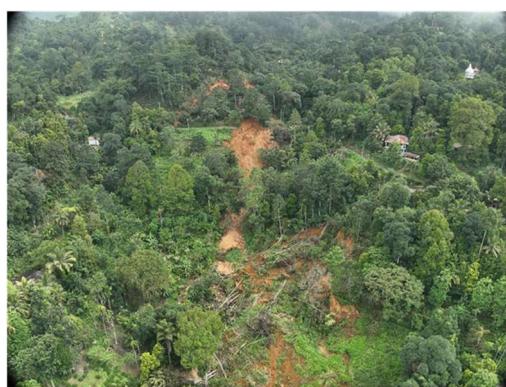
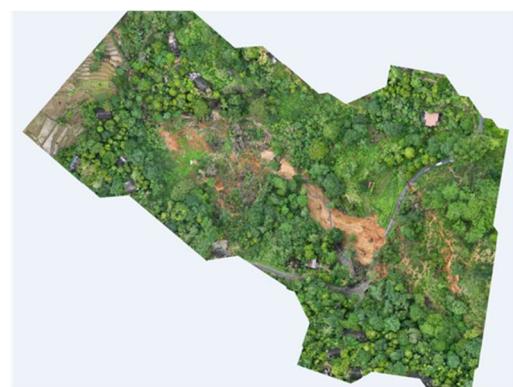
The landslide occurred across the road, in an area characterized by a steep downslope. Part of the B180 road was completely destroyed by landslide debris and displaced downslope into the valley. The soil mass has lowered by approximately 4–5 m in the crest area, and the ground surface at the road level has decreased by approximately 1–1.5 m.

The main issue is that further failures can occur during the rain due to water infiltration into the landslide body and uncontrolled surface runoff along the slope. The landslide may be reactivated during heavy rainfall, since the failed mass remains in a very unstable condition. The road section is currently inaccessible to traffic.

*Photo 1 - Overall views of the landslide.*

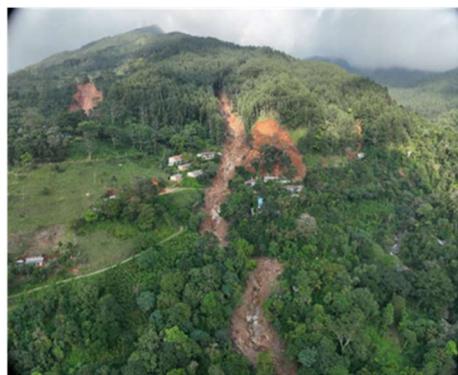
Three landslides were identified along the Gammaduwa-Karagahathenna road. The primary landslide is of rotational type, evolving into a flow, and consists of two bodies, the larger of which extends approximately 200 m at the crown and about 2 km in length. The other two landslides could not be surveyed by drone due to site inaccessibility and increased wind conditions. The landslides were triggered by the nature of the terrain (highly altered and unstable metamorphic rocks), the slope of the rock layers, degradation from vegetation roots, and recent exceptional rainfall.

*Photo 1 - Overall view of the landslide.*
