# Advisory Mission on Infrastructure Resilience after Cyclone Ditwah

## FINAL REPORT

10-21 December 2025

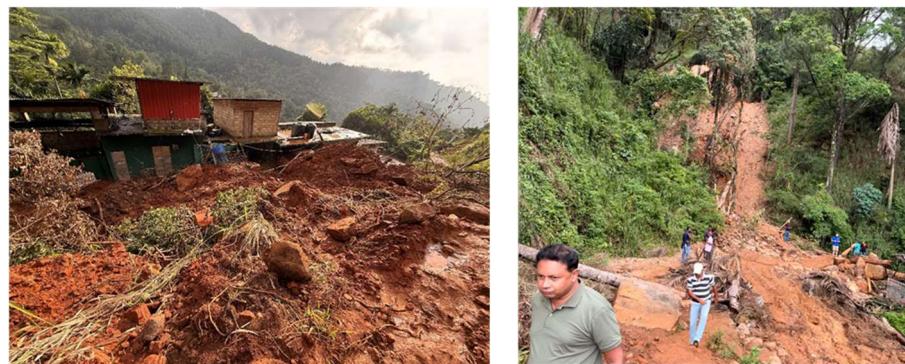
Three landslides were identified along the Gammaduwa-Karagahathenna road. The primary landslide is of rotational type, evolving into a flow, and consists of two bodies, the larger of which extends approximately 200 m at the crown and about 2 km in length. The other two landslides could not be surveyed by drone due to site inaccessibility and increased wind conditions. The landslides were triggered by the nature of the terrain (highly altered and unstable metamorphic rocks), the slope of the rock layers, degradation from vegetation roots, and recent exceptional rainfall.

Investigations conducted on the ground and by drone revealed three large landslides along the slope, the most significant of which caused the death of 2 people and the destruction of 4 buildings, as well as the interruption of road links to inhabited areas. The adjacent landslide, which was equally significant in size, also caused the destruction of roads, but did not result in any casualties. Further drone inspections were not possible due to the inaccessibility of the sites and strong winds. However, it was concluded that, at present, the conditions in the area require continuous monitoring of the situation, which is still evolving due to the presence of water in the landslide and movements that are likely still ongoing.

*Photo 2 – Detailed views of the landslide.*

The entire area examined is characterized by the presence of highly altered metamorphic soils with a predominantly gravelly matrix, which are highly permeable and susceptible to landslides, some of which are significant, due to the abundance of water. Due to the damage to the only access road caused by at least three landslides, it's recommended that any residents in the area be evacuated and access to the area be prohibited, especially during intense weather events. Not only in the areas affected by landslides, but also on nearby slopes, an assessment of the post-event risk is recommended to monitor the possible evolution of the observed phenomena, including through the use of drones. It is also recommended to install a slope monitoring systems, including rapid or temporary ones, connected to an early warning system (EWS) for the protection of the resident population.

The presence of significant surface water and groundwater within the landslide-affected area may contribute to further slope instability in both the affected and surrounding areas, potentially resulting in additional damage and loss of life. Considering the large volume of the landslide body, priority should be given to the implementation of surface and subsurface drainage measures to reduce groundwater pressures within the landslide mass and adjacent slopes. These measures should be complemented by progressive slope regrading and reshaping interventions aimed at reducing overall slope angles and mitigating the risk of future landslide reactivation. Monitoring systems (satellite imagery, LiDAR or inclinometers) must be installed covering the entire intervention area to verify the effectiveness of the hydrogeological risk mitigation and drainage measures and to plan any further stabilization work in the area, through slope modelling and instability containment measures. It is suggested to implement a systematic maintenance of the slope, drainage system, and protective works. It is also suggested to establish an in-situ monitoring system (satellite imagery, LiDAR or inclinometers) with periodic review and validation of the EWS, incorporating lessons learned from future events and climate change projections to localize rainfall thresholds of the EWS.

It is recommended that the monitoring systems installed in the medium term be maintained in place also in the long term, to protect residents in extreme weather events and assess the long-term
